## **Summary of EPA Surface Water Sampling of Select Metals Results to Date**

### **Gold King Mine Blowout**

August 7, 2015

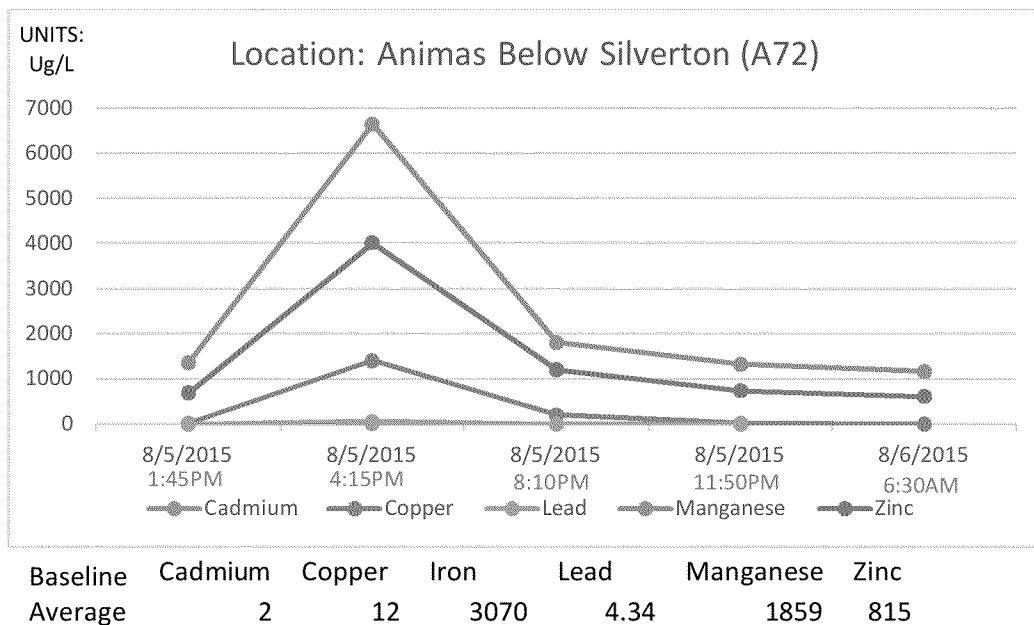
The third graph demonstrates the data from the Animas River just below the town of Silverton (A72). The graph shows an initial spike in metals concentrations with levels returning to historical averages by the morning of August 6, 2015.

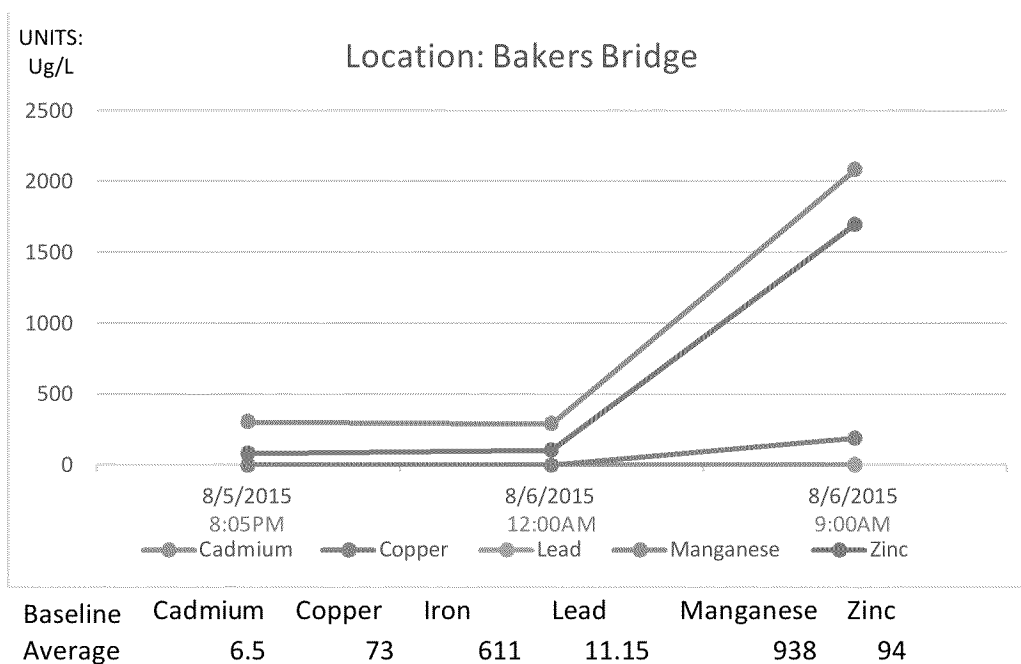
The fourth graph demonstrates the data from Bakers Bridge on the Animas River just above Durango, CO. Since this location is about 20 miles from Silverton, the metals concentrations are

increasing above historical averages. But, it is believed that subsequent data collection activities will demonstrate a decrease in concentrations similar to those seen at upstream locations.
